EFFECTS OF TEXO #502AF

AND PENNSALT CLEANER #4L

PAINT STRIFPERS ON

COMMONLY USED AIRCRAFT MATERIALS

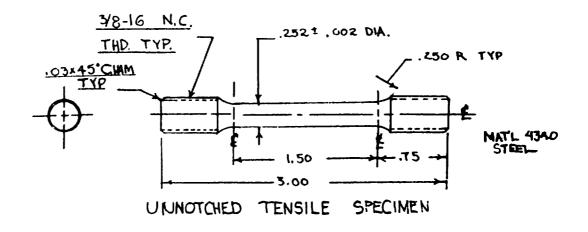
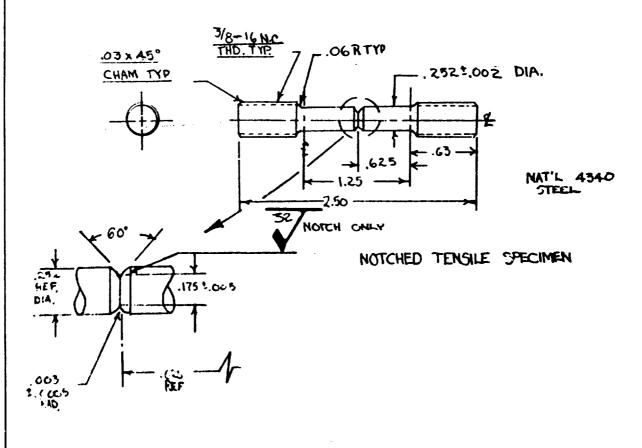
FIGURE 1

The tensile strength specimens were prepared as shown in Figure 1, page 23, of this report.

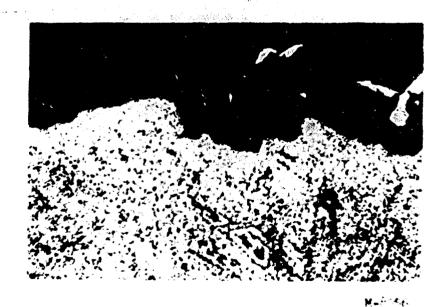
FIGURE 12 - PHOTOMICROGRAPH (250X) OF MTS SPECIMEN EXPOSED TO TEXO NO. 1 CAP FOR EIGHT HOURS AND LOADED TWENTY-FOUR HOURS AFTER REMOVAL

Metallographic specimens of NT3 specimens 7, 19, 41 and 39 were made to determine whether either paint stripper caused intergranular corrosion. Figures 11 through 14, pages 33 through 34 are photomicrographs (250X) of the failure surface. There was no apparent intergranular corrosion in any of the specimens.

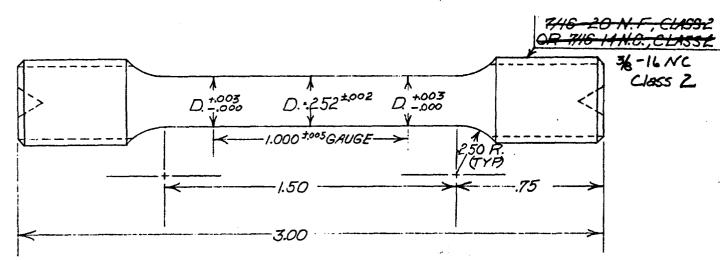
NOTE: TAPER OPTIONAL. IF NOT TAPERED, DIAMETER OF REDUCED SECTION SHALL NOT VARY BY MORE THAN ±.0005. DIAMETER AT EITHER END SHALL NOT BE LESS THAN DIAMETER AT CENTER.

SMOOTH TENSILE SPECIMEN
FIGURE 3

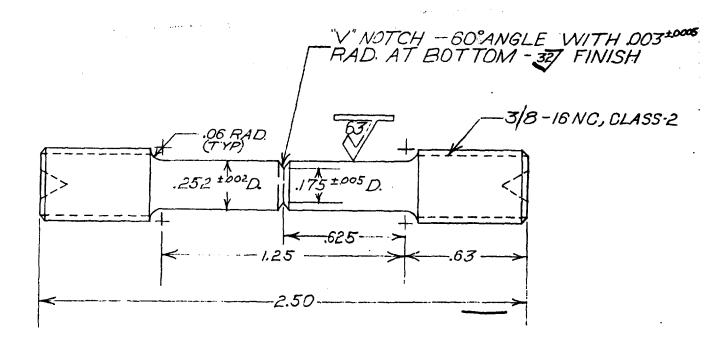
- I. CONCENTRICITY WITH RESPECT TO NOTCH AND THREAD MUST BE KEPT WITHIN .001 T.I.R.
- 2. TOOL CHATTER, METAL TEARING, OR TOOL MARKS IN THE NOTCH WILL CAUSE REJECTION.
- 3. DO NOT BUFF OR GRIND NOTCH RADIUS.
